1. AGENCY USE ONLY (Leave Blank)		2. REPORT DATE 5/14/02		3. REPORT TYPE AND DATES COVERED Final Report 1 July 01 to 28 Feb 02
4. TITLE AND SUBTITLE A Palm Size Micron-gap ThermoPhoto Voltaic (MTPV) Energy Converter			5. FUNDING NUMBERS DAAD19-01-C-0064

**A Palm Size Micron-gap ThermoPhoto Voltaic (MTPV)
Energy Converter**

Final Progress Report

The Charles Stark Draper Laboratory, Inc.

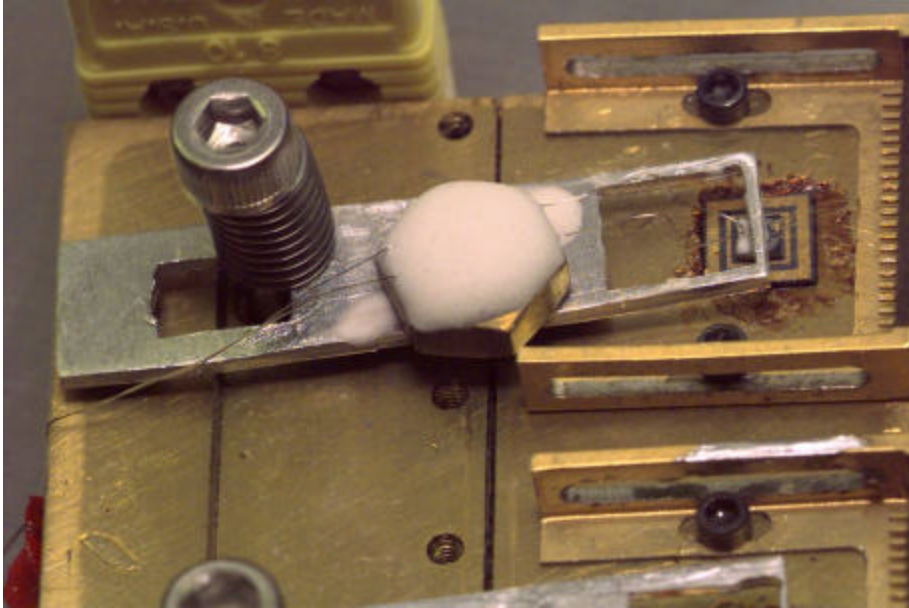
Test specimen assemblies were first built for small gap MTPV testing. This fixturing which was used for the testing reported below is shown in Illustration 1.

Illustration 1. Experimental Configuration of Heater Chip and PV Cell

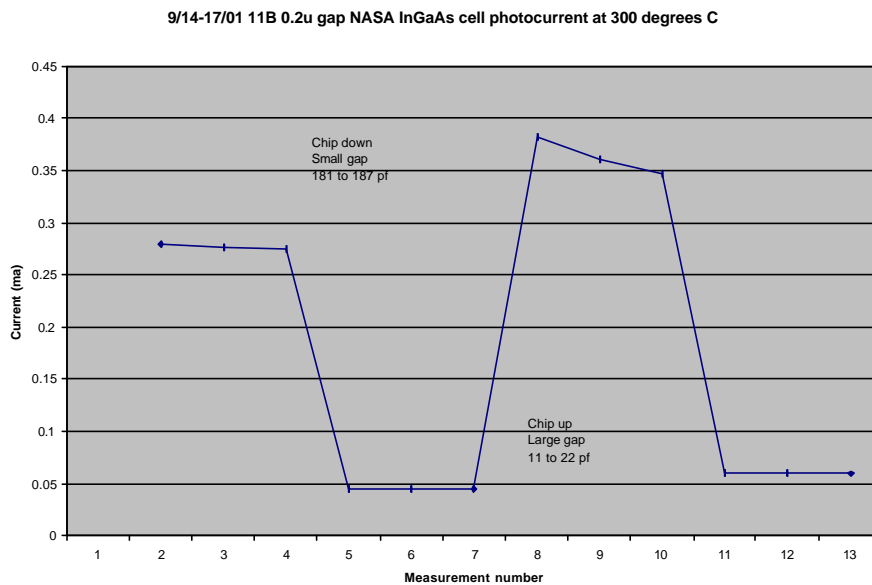
Tests were performed with 0.2 micron gap heater chips on InGaAs photovoltaic cells provided by Dave Wilt at NASA Glenn. Results for small gap (down) and large gap (up) experiments at 300°C, 400°C, and 500°C are shown below in Illustrations 2, 3, 4, and 5.

Illustration 2. 0.2 Micron Heater Chip, Large Gap – Small Gap Data – 300°C – on InGaAs Cell

Illustrations 7 and 8 show the results of Heater Chip Power Off testing. In both small gap (“DOWN”) and large gap (“UP”) positions heater power (yellow lines) was shut off and the short circuit currents (green lines) did not shut off but thermally decayed demonstrating that the short circuit current enhancement demonstrated in Illustrations 2-6 were not artifacts of the heater electrical power.

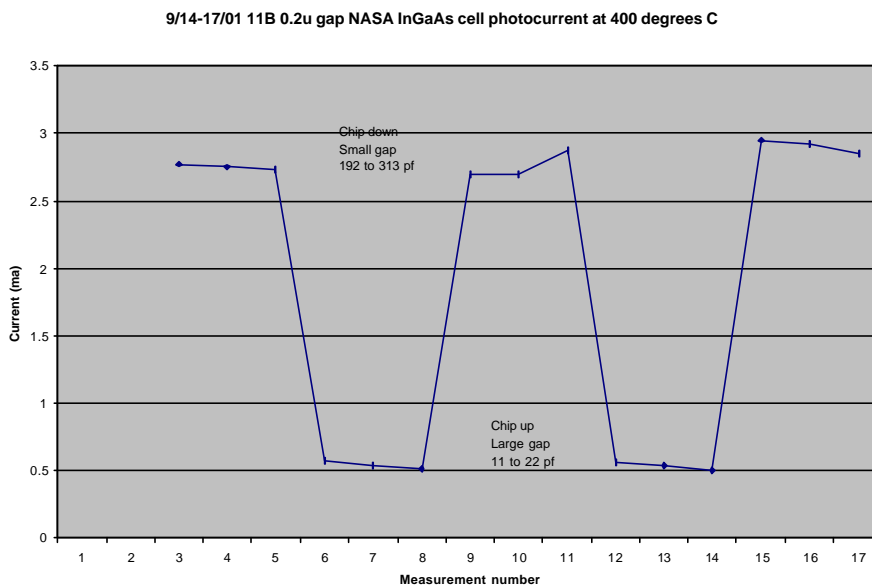
Illustration 3. 0.2 Micron Heater Chip, Large Gap – Small Gap Data – 400°C – on InGaAs Cell

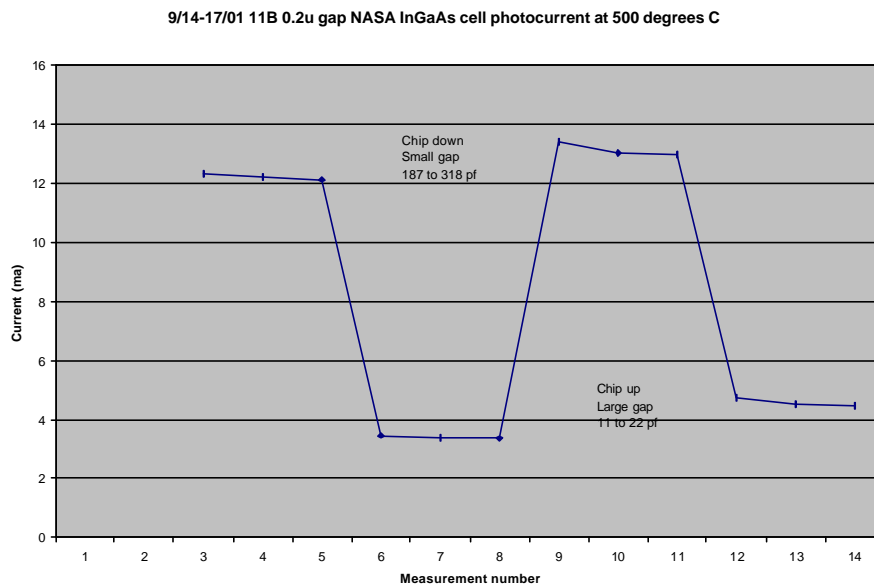
Illustration 4. 0.2 Micron Heater Chip, Large Gap – Small Gap Data – 500°C – on InGaAs Cell

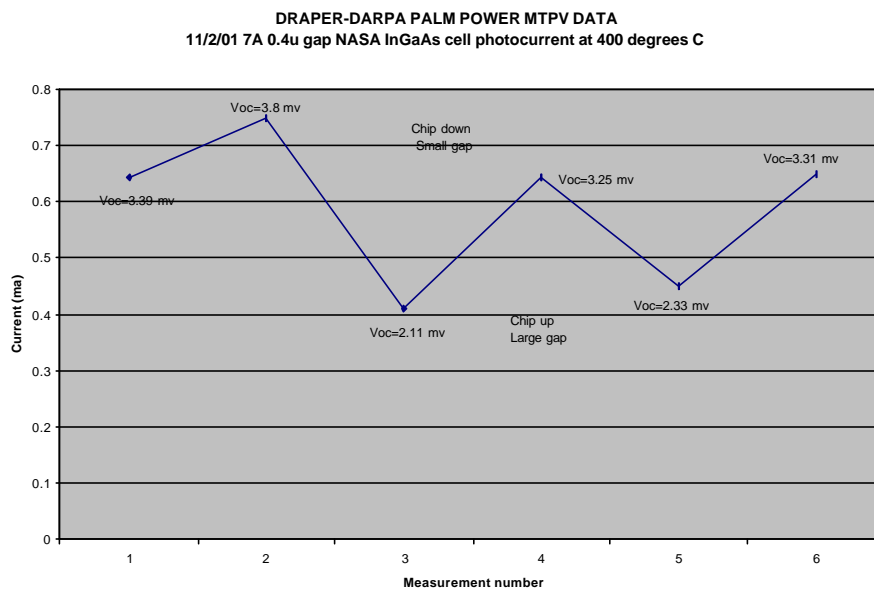
Illustration 5. 0.4 Micron Heater Chip, Large Gap – Small Gap Data – 400°C – on InGaAs Cell

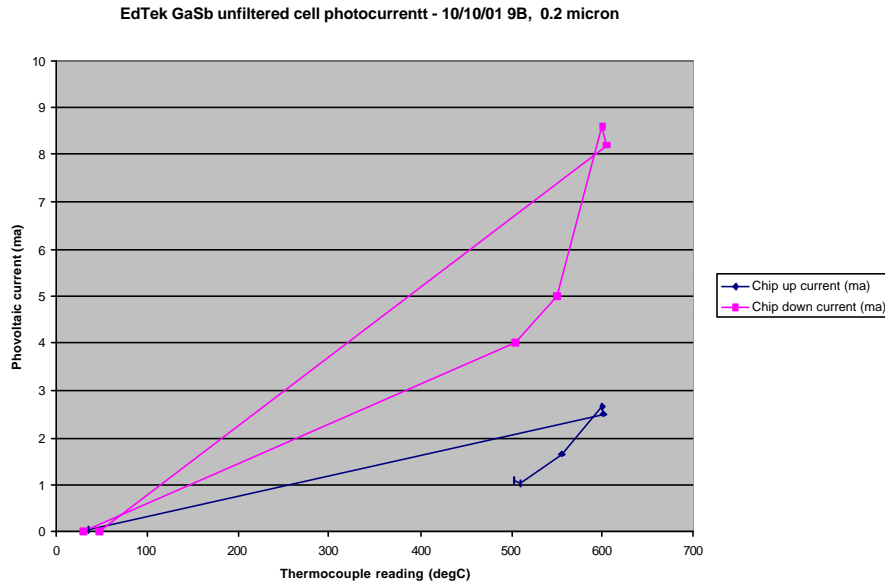
Measurements with 0.2 micron gap heater chips were also made with 0.74 eV GaSb photovoltaic cells supplied by EdTek. The results are shown below in Illustration 6.

Illustration 6. 0.2 Micron Heater Chip, Large Gap – Small Gap Data – 500-600°C– on GaSb Cell

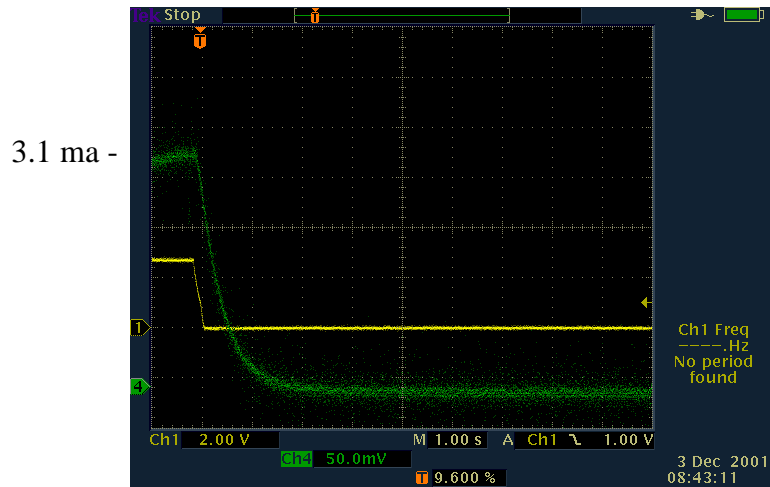
DOWN

Illustration 7. Heater Power Off Test – Small Gap

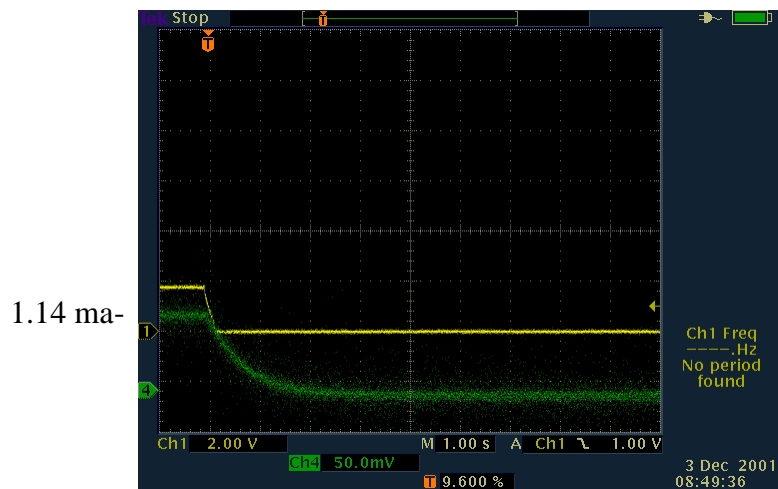
UP

Illustration 8. Heater Power Off Test – Large Gap
